ISSUE

My Tap Head is not functioning properly.

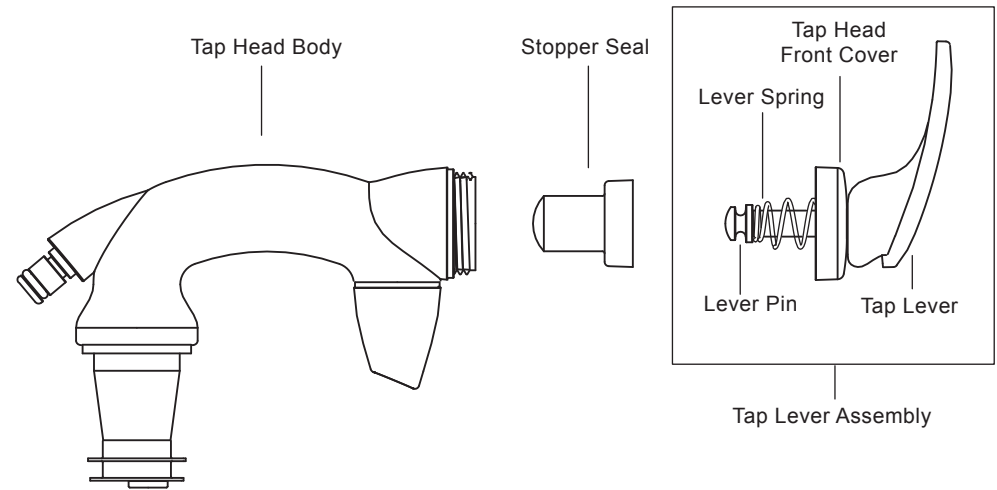
Most Tap Head issues originate from the Stopper Seal coming loose from the Tap Lever Assembly. This can easily be corrected by following the steps below. While disassembling the Tap Head take this opportunity to clean all of the components.

Note: The Stopper Seal may come loose from the Tap Head Lever Assembly when the Tap Lever is rotated. To help in preventing this issue only rotate the Tap Lever upon initial setup of your system.
